# REPUBLIC OF TURKEY GOVERNORSHIP OF SAMSUN PROVINCIAL DIRECTORATE FOR DISASTER AND EMERGENCY MANAGEMENT SAMSUN, TURKEY

# GIS APPLICATIONS FOR DISASTER MANAGEMENT IN SAMSUN CITY (NORTH TURKEY)

# DISASTER MANAGEMENT OF REGIONAL DISASTERS OCCURRED ON 9 JULY 2012 IN SAMSUN CITY, (NORTH TURKEY)

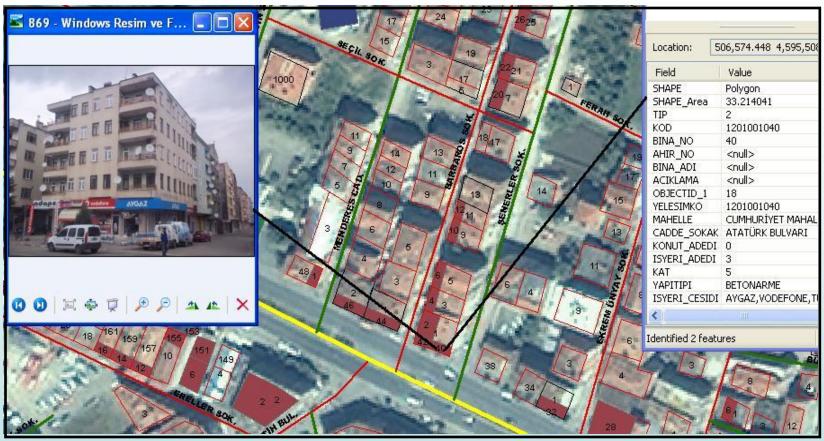
One of the urban settlements in Ondokuzmayıs. (Left) Selected structure photo and (right) attribute table of this structure on the plotted structure map.

Photos of all structures have been taken for post-disaster studies. After the field work, data collected from the study area, have been added as nongraphic in the pre-plotted structures and attribute tables of all structures has also been created, which consist of type, storey height, year of built, usage, office qualification, and cadastral info data.

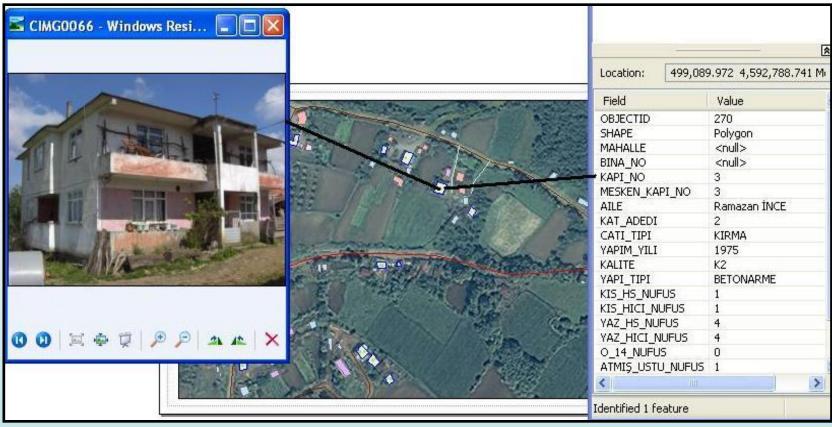
One of the rural settlements in Karacaoğlu Village, Ondokuzmayıs. (Left) Selected structure photo and (right) attribute table of this structure on the plotted structure map.

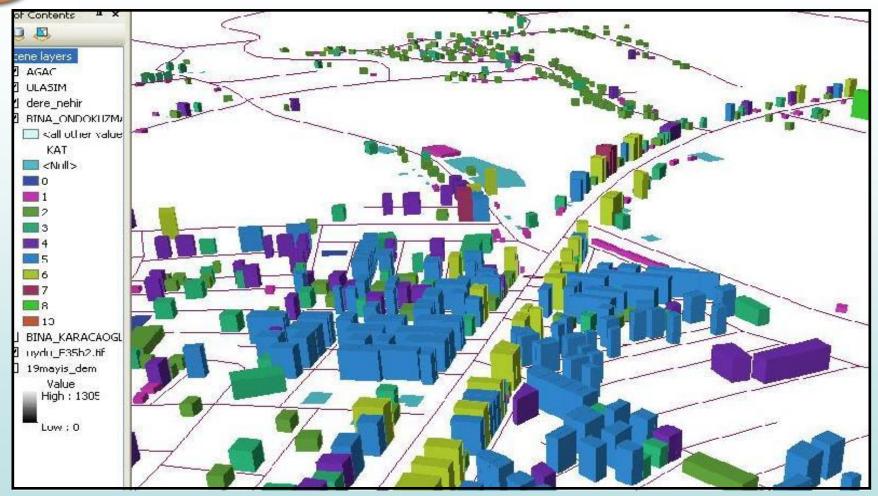
3d modelling for storey height in central Ondokuzmayıs

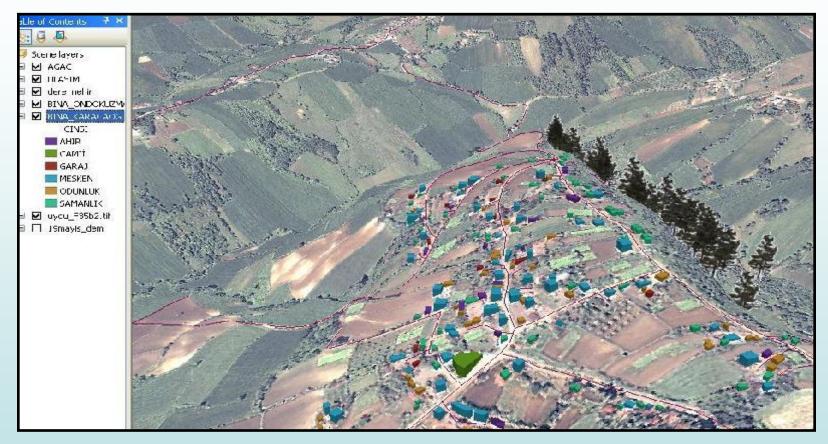
3-dimensional modeling for usage classification of the rural settlements in the Karacaoğlu Village, Ondokuzmayıs.

1:25000 scale topography map (MTA) has primarily been digitized for 3-dimensional modeling. The digital elevation model and maps of slope, aspect, and elevation have been created, respectively. 3-dimensional modeling has lastly been generated for usage classification.

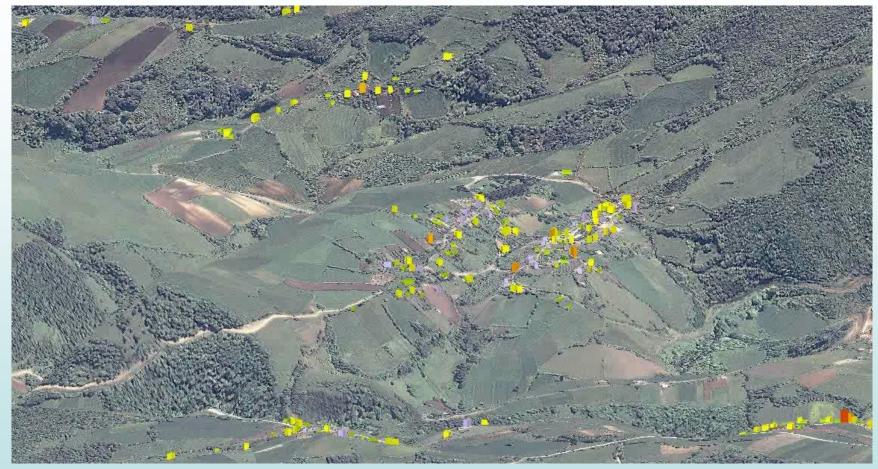
3d modelling from south to north

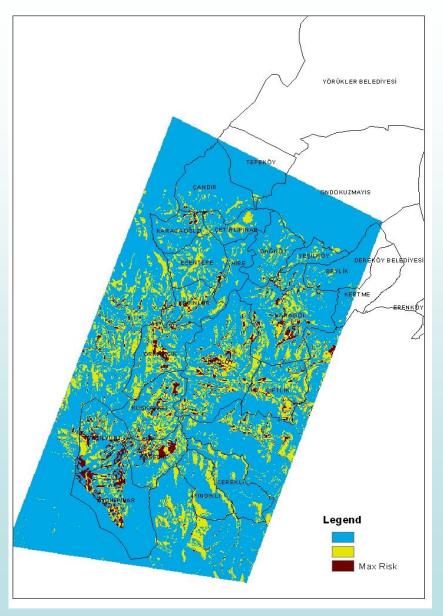
1:25000 scale landslide susceptibility map of Ondokuzmayıs

Landslide susceptibility map of Ondokuzmayıs has been generated using **frequency ratio method** (Akgün, 2007; Akgün *et al.*, 2008; Akıncı *et al.*, 2010; Akıncı *et al.*, 2011; Dağ and Bulut, 2012) which is widely used in literature.

Parameters of slope, aspect, elevation, steepness, road network, and river network have been take into account in application.

Generated landslide susceptibility map has been supported by 1:25000 scale digital landslide inventory map (MTA) and **empirical determination of paleo-landslide**.

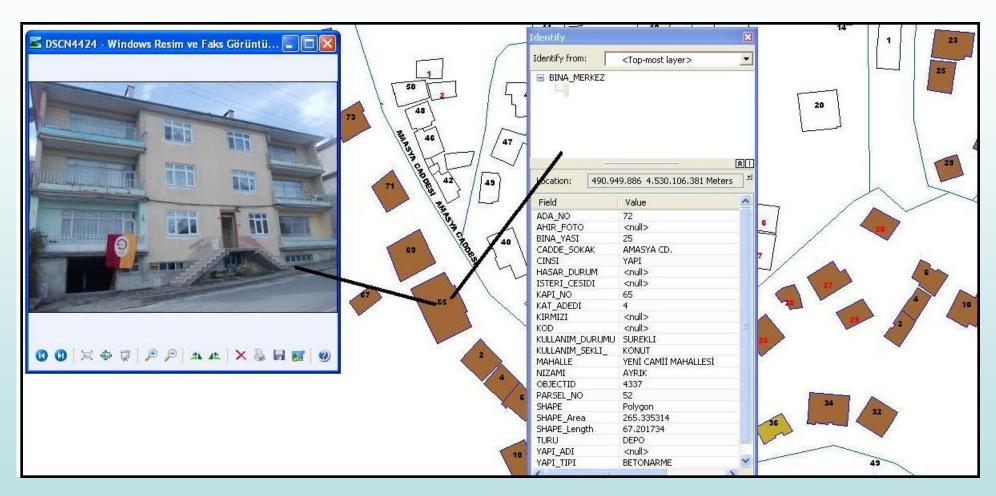
Structure inventory in Yenicami section of Ladik (concrete structure)

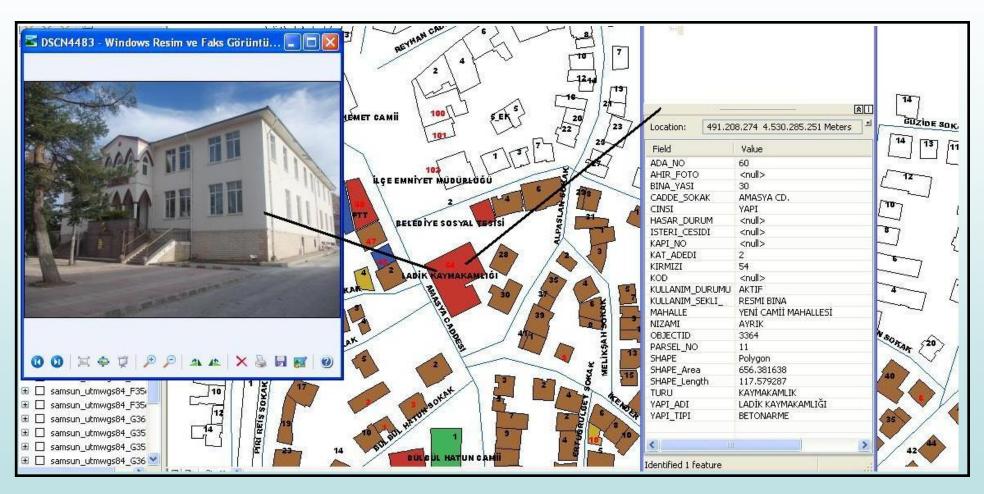
Structure inventory in Yenicami section of Ladik (governmental structure)

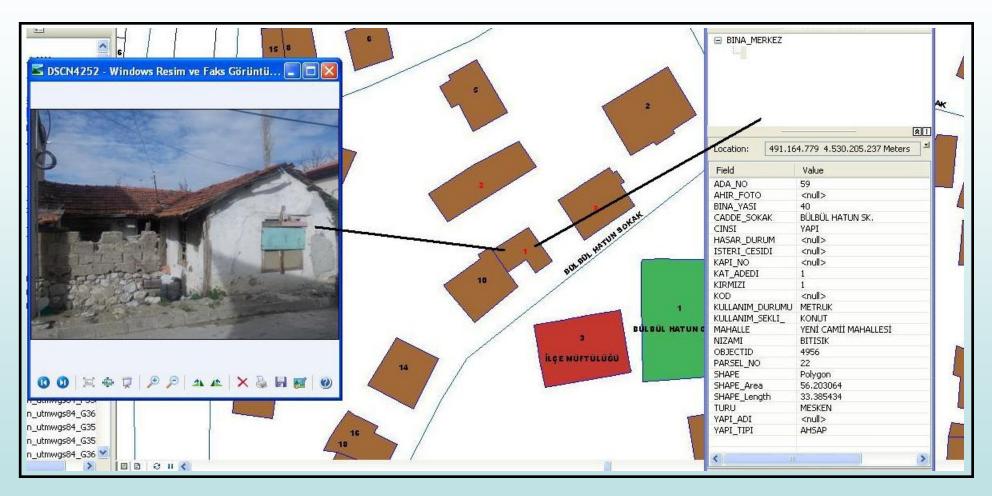
Structure inventory in Yenicami section of Ladik (abandoned structure)

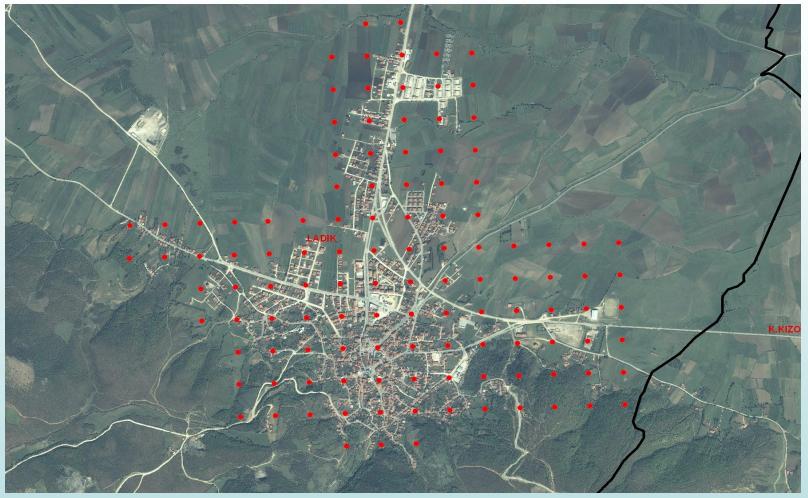
Mesh system in central Ladik. Red spots, totally 118, are 200 metres far away from each other

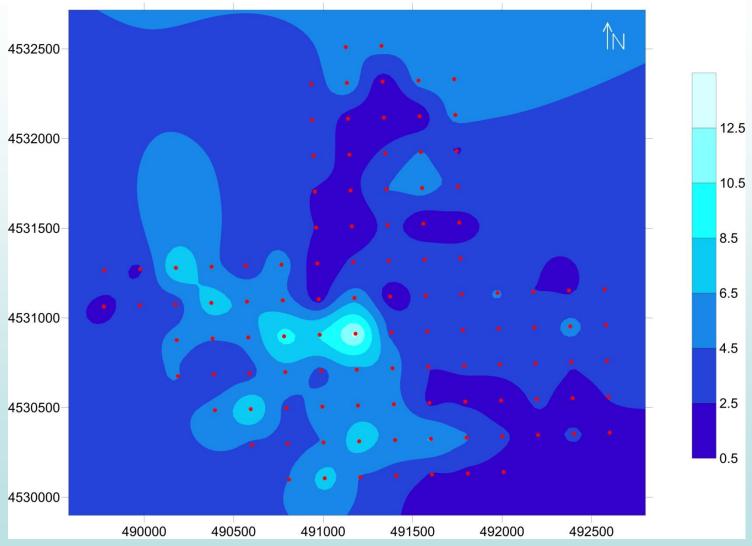
Map of the predominant frequency (Hz)

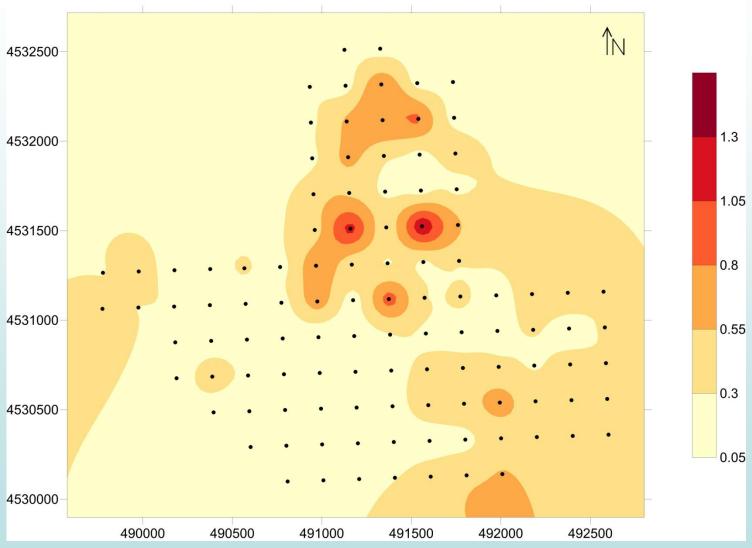
Map of the predominant period (s)

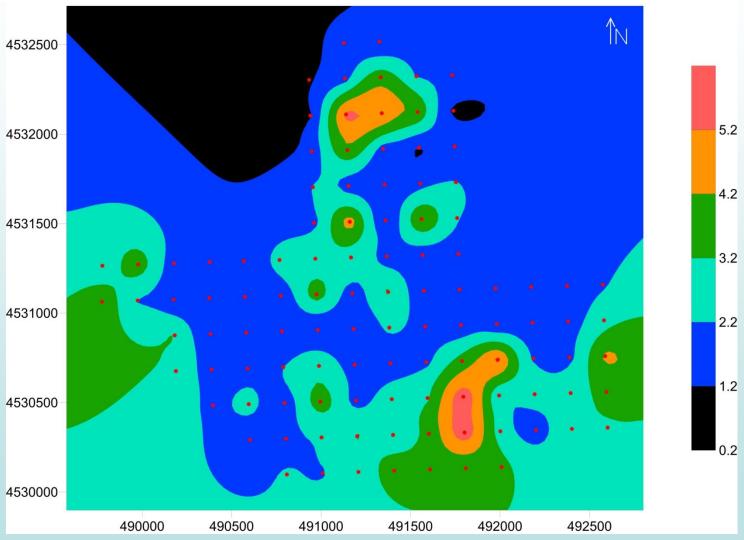
Map of the ground amplification

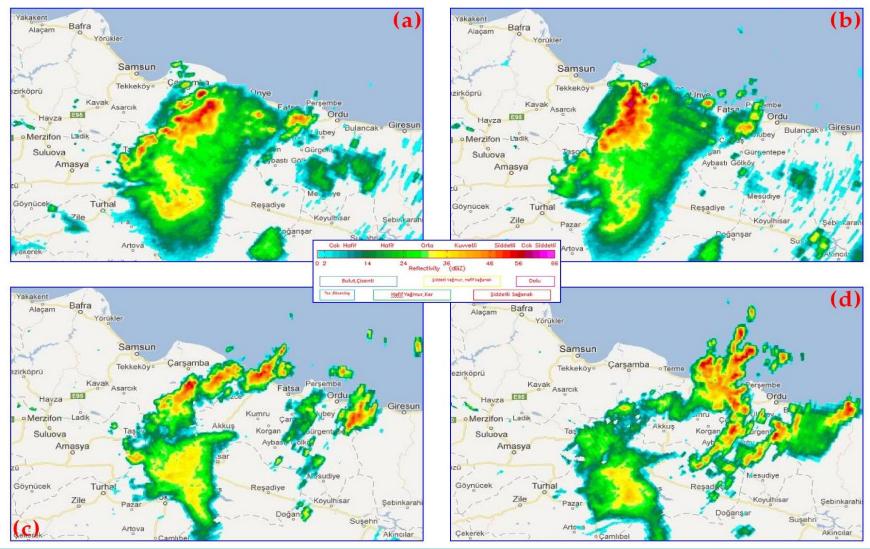
Real-time meteorological satellite images have been represented the times of (a) 19:30, (b) 20:30, (c) 21:30, and (d) 22:30, respectively.

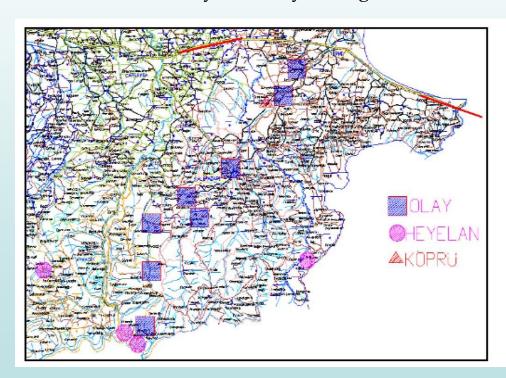
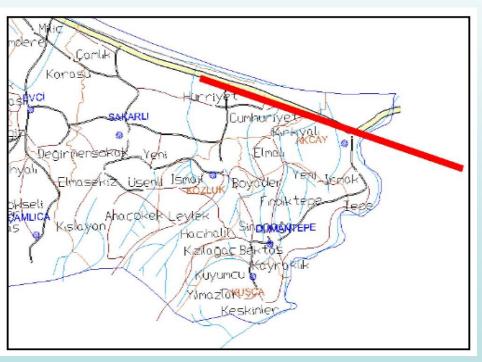
Events, occured in 4 districts, on the 2d map. Additionally, in order to ensure traffic security, Samsun-Ordu highway (eastern) was closed up for a period of 30 minutes.

In Disaster Management Center, we followed the 3d models of Salipazari-Terme region and warned some villages headmen, who live in the villages parallel to steep valleys. Terme River, which enlarged by tributary river from southern Salipazari district, caused flood in the city center and heavy traffic on the bridges. Sivaslılar and Çangallar villages have temporary been discharged and transferred to safety zones by local government for overflow risk in Terme district.

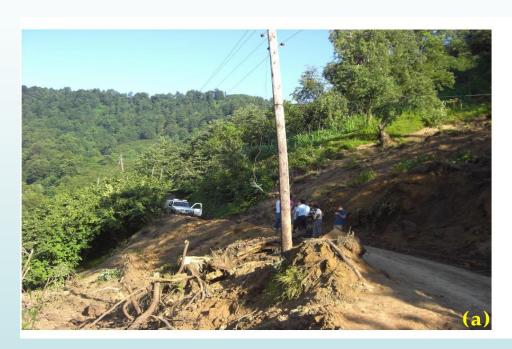
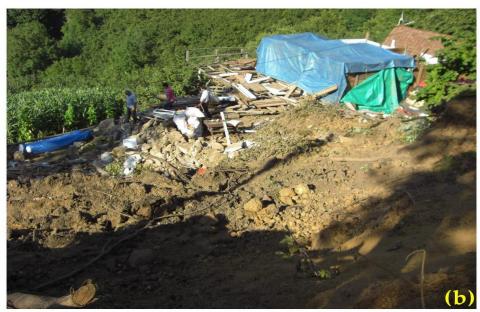
Demolished wooden structure because of the landslide in Kestanepınar Village, Çarşamba district.
